## PROPERTY INSPECTION REPORT

**Prepared For:** John Trembly  
(Name of Client)

**Concerning:** 2924 68th, Lubbock, TX  
(Address or Other Identification of Inspected Property)

**By:** Chad Price, Lic #10599 08/29/2020  
(Name and License Number of Inspector) (Date)

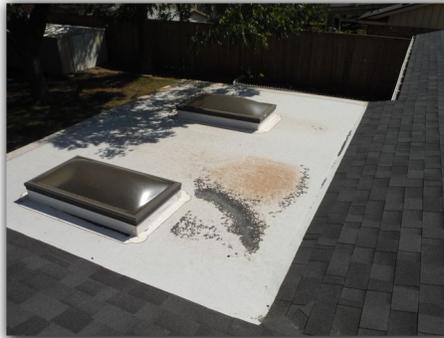
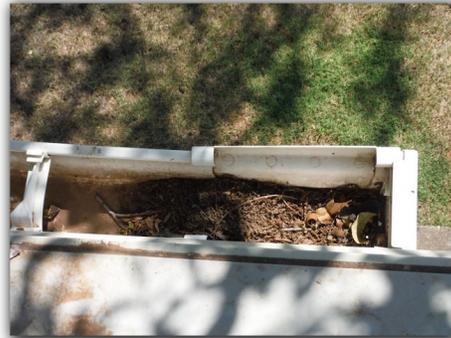
- evidence of water ponding at rear porch
- debris in gutters
- disconnected rear gutter
- trees overhang the roof

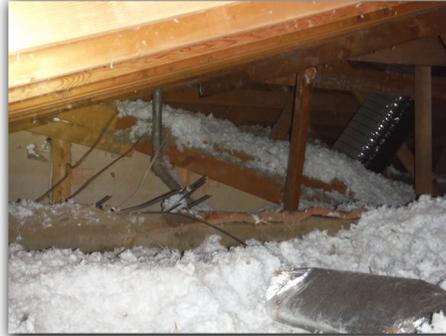
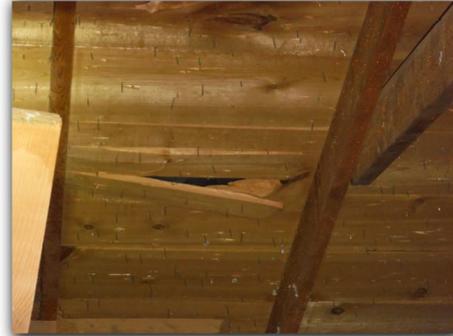
- observed missing areas of vertical insulation
- observed damaged roof decking

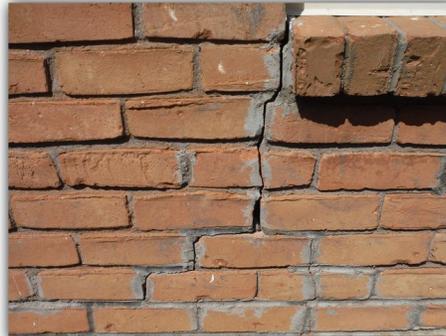
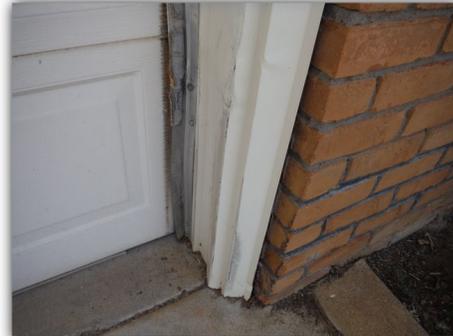
- observed repaired/cracks in brick mortar joints
- damaged metal trim around garage doors
- observed shallow/missing brick mortar joints
- missing wall board under kitchen sink
- observed small areas of cracked/damaged/repared drywall
- observed small areas of cracked caulking and peeling paint
- holes in garage drywall
- cracked garage drywall

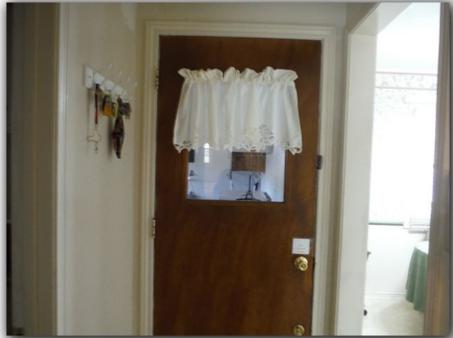
- solid door with no openings required at door into garage
- rear storm door did not latch
- peeling veneer at exterior storage closet

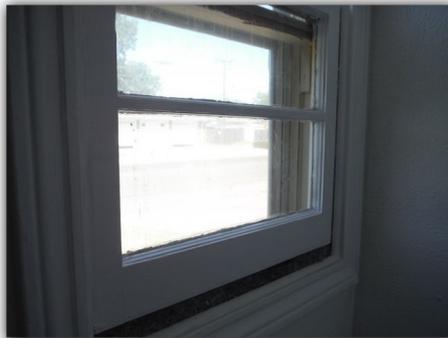
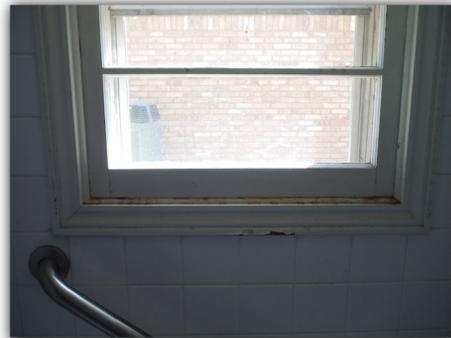
- master bathroom window did not fully close (painted shut)
- safety glass not present at window above bathtub
- observed damaged screens
- master bedroom right windows painted shut
- cracked/damaged hall bathroom window putty

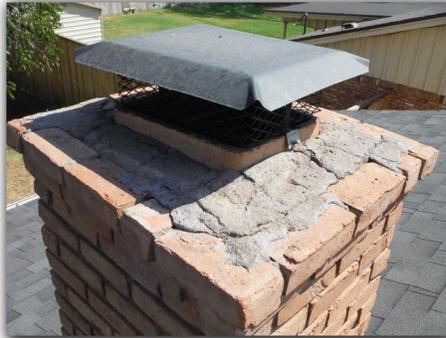
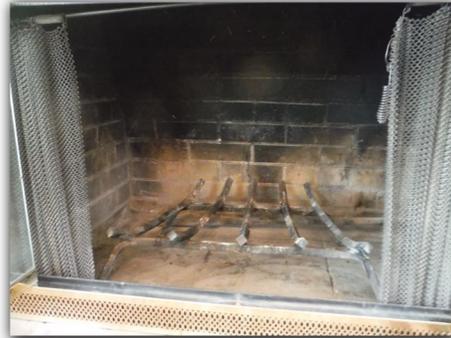
- cracks in mortar cap
- light cracks in firebox
- observed soot in chimney

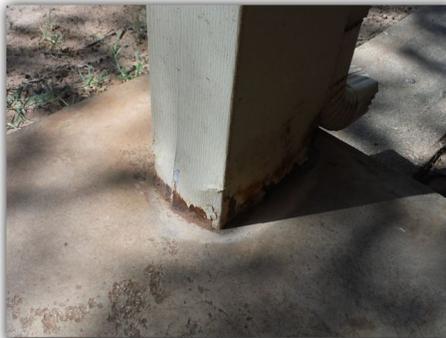
- rust at porch post metal
- cracked rear porch boards

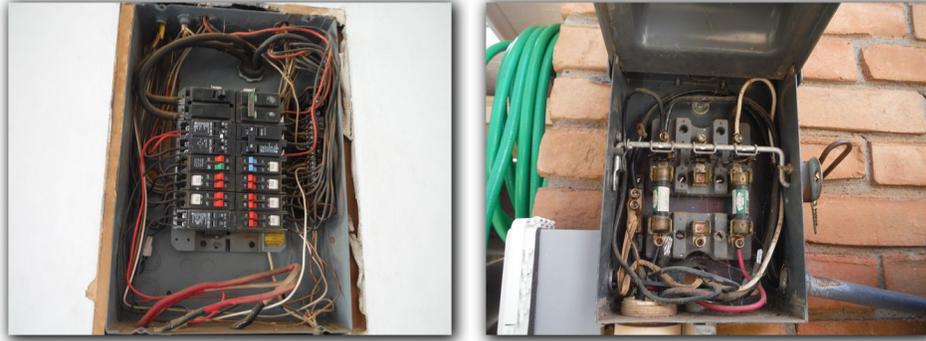
- observed permanent screw not installed at back fed breaker
- wire protection missing at bottom of knockout
- abandoned wires in panel
- abandoned wires at disconnect
- double wires at disconnect
- no front cover at disconnect
- panel not fully labeled
- over head service wires in contact with trees
- no anti-oxidants present at aluminum wire connections

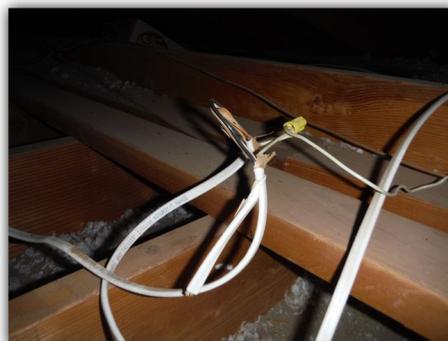
- open wire joints in attic
- observed painted plugs
- electrical cord protection missing at furnace
- no a/c disconnect at condensing unit
- unbalanced living room fans
- GFCI protection not installed at required locations: exterior, bathroom, kitchen and garage plugs
- observed smoke alarms not installed in all bedrooms and in hallway(s)

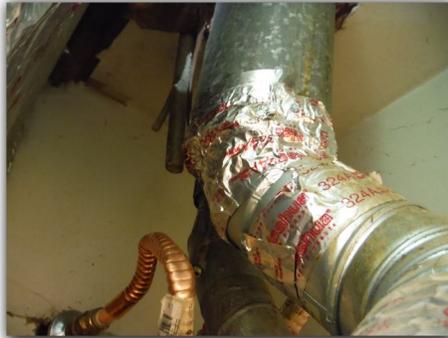
- no vent increaser installed at furnace
- the heater operated correctly

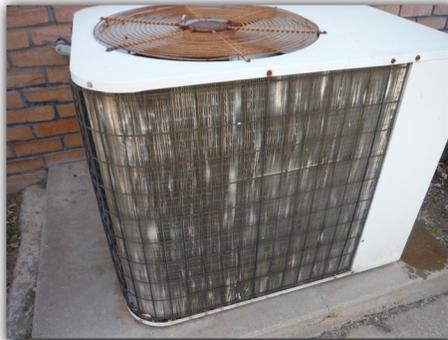
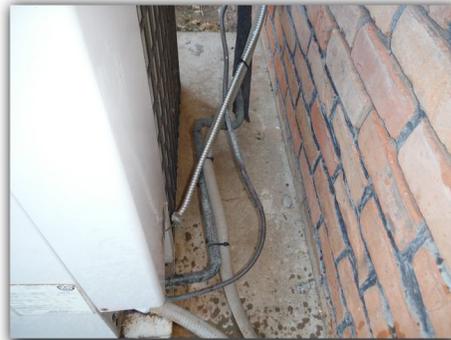
- observed damaged fins at a/c unit
- insulation missing on a/c piping at exterior
- Supply: 56 degrees      Return: 73 degrees  
(good temperature difference)

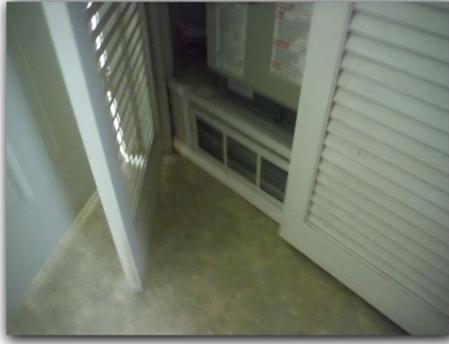
- return air grill installed inside mechanical closet
- unsealed hole in plenum platform

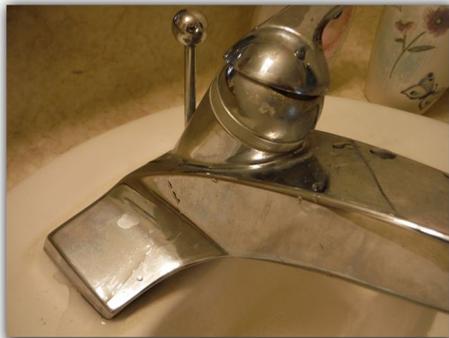
- leak under hall bathroom south lavatory handle
- exterior gas pipe not sleeved through brick
- kitchen RO drain piped to sewer side of p-trap
- observed hall bathroom tub/shower diverter did not work properly
- hall bathroom south lavatory aerator partly stopped up
- hall bathroom tub spout not installed flush with wall

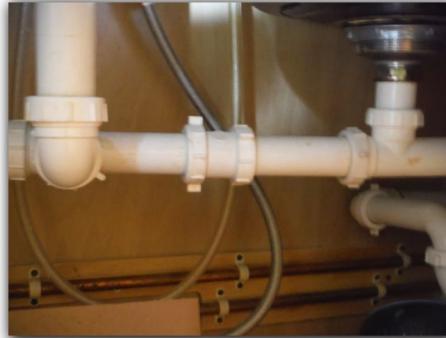
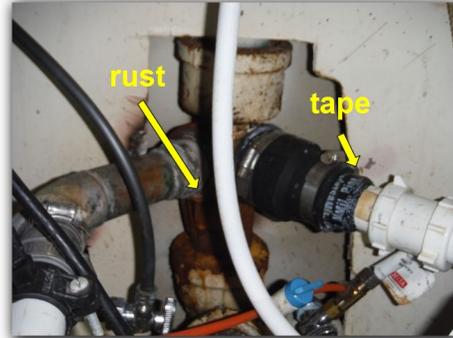
- sanitary tee receiving waste at laundry room sink
- rusted/corroded drain pipe under kitchen sink
- taped up kitchen drain pipe
- master bathroom lavatory drain stop did not stay closed
- corroded hall bathroom lavatory drains
- corroded hall bathroom south water valve

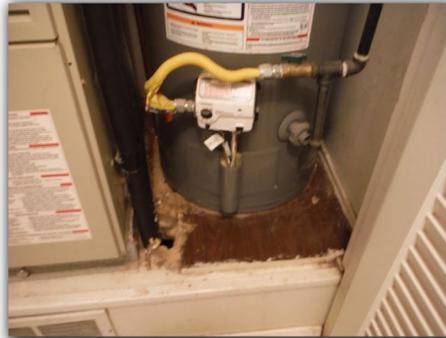
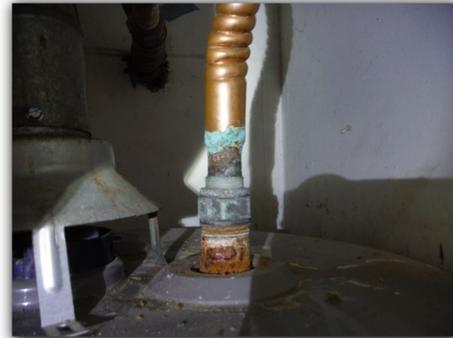
- no water heater pan
- rusted pipe on top of water heater
- t&p piping does not terminate in same room at water heater
- observed screws missing at single wall vent pipe connections
- observed unusual noise at water heater

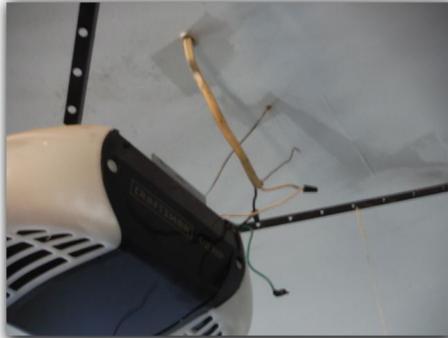
- the garage door is hardwired (open wire joints)
- observed safety photo eye sensors greater than 6" above garage floor

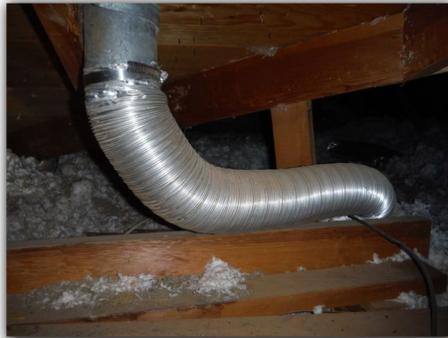
- observed flexible dryer duct installed in attic

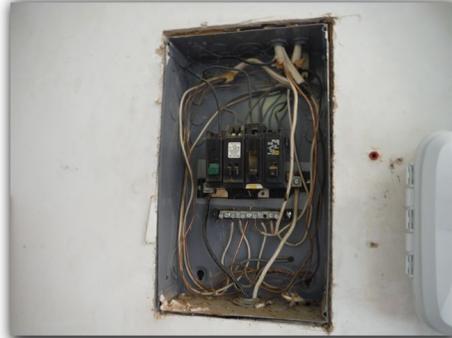
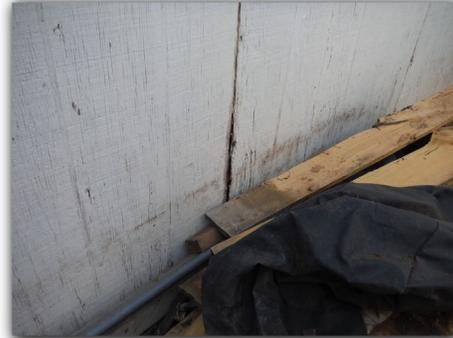
- panel not fully labeled
- two missing screws at panel cover
- #12 wire on 30 AMP breaker
- double wires on 20 AMP breaker
- water damage at siding
- exposed wiring
- peeling veneer at door
- evidence of water ponding
- peeling paint and cracked caulking
- observed loose wood trim
- front door binds/drag
- taped up wire joints
- no GFI's at plugs
- missing plug covers
- bathroom door drags
- toilet installed in shower
- unusual noise at toilet and shower drain
- no shower trim installed above shower
- missing hot water knob
- drip at lavatory
- s-trap installed at lavatory
- previous water damage under lavatory (mildew like substance)
- hot water not piped
- leak at toilet tank
- loose shower knob
- observed exhaust did not work
- missing door striker
- damaged drywall
- no attic access
- debris in gutters
- exposed nails on roof
- no soffit vents installed
